Field Study of Exterior Walls in a Hot and Humid Climate

In-situ monitoring and performance analysis of stone wool exterior insulation

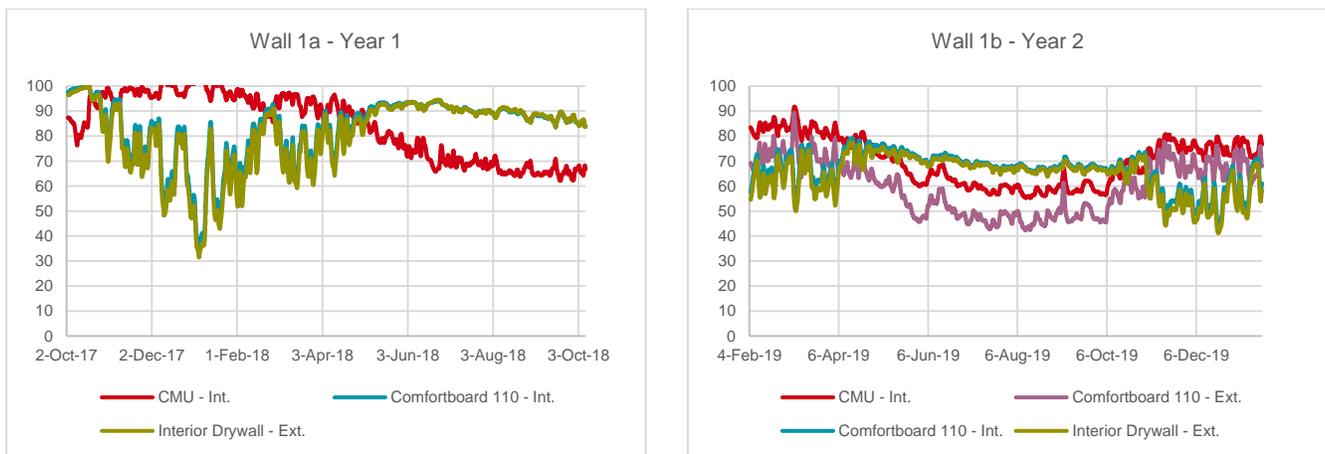
In Year 1, the CMU substrate had high RH levels largely attributed to construction moisture, specifically the mortar fill. However, in Year 2 the CMU clearly demonstrated drying of initial moisture levels indicated by the lower overall RH levels. On the interior side of the assembly, high RH levels are noted in the summer months of Year 1 caused by inward vapor drive. In Year 2, due to the drying of initial moisture and the addition of the WRB membrane, the interior RH levels within the assembly were significantly lower.

Figure 1 & 2: Wall 1, Year 1 and Year 2 relative humidity (RH) levels, 24hr running average

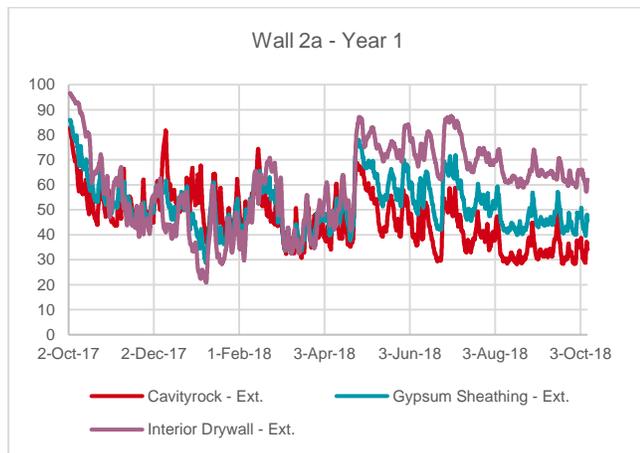
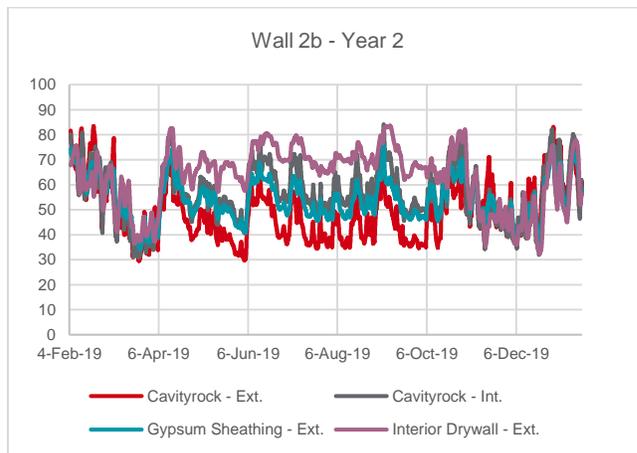
The RH levels within the assembly remained below the desired threshold of 80%. The exterior surface of the interior drywall had the highest peaks in the summer months due to inward solar drive. The change to a lower perm WRB in Year 2 resulted in lower overall values. Even with the highly absorptive brick cladding, the ROCKWOOL Cavityrock® demonstrated adequate drainage and drying without any indication of potential moisture accumulation within the wall assembly.

Figure 3 & 4: Wall 2, Year 1 and Year 2 relative humidity (RH) levels, 24hr running average

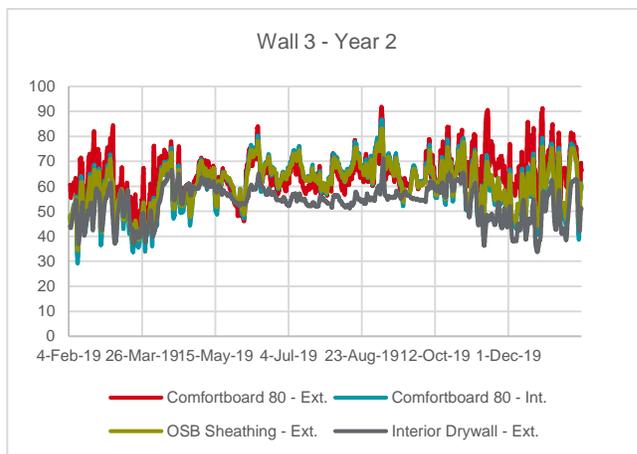
The RH levels within the assembly remained below the desired threshold of 80%, specifically for the OSB sheathing and interior drywall. The short peaks of higher moisture on the exterior side of the assembly demonstrate effective drainage and drying of the ROCKWOOL Comfortboard™ 80 continuous insulation.

Figure 5: Wall 3, Year 2 relative humidity (RH) levels, 24hr running average
